## 危險性機械

## 固定式起重機的安全裝置與警報裝置

## 固定式起重機災害剖析

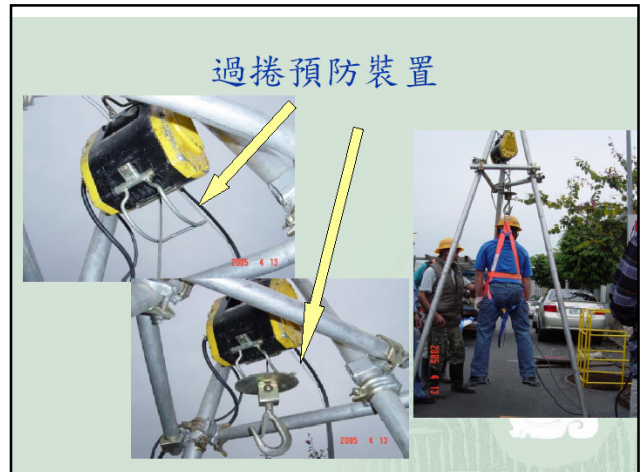
1. 過捲預防裝置及其警報裝置
2. 橫行安全裝置及警報裝置
3. 直行安全裝置與警報裝置
4. 過負荷或翻倒安全(懸臂式)警報裝置
5. 其他安全及警報裝置

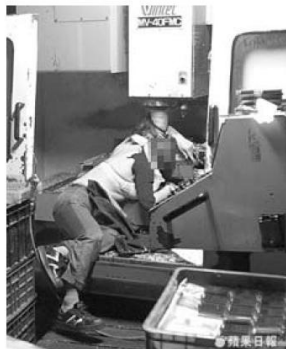
台北縣林口鄉昨天發生一起工安意外，一名非法打工的越南籍女子范氏貴，昨晨在清理電腦銑床機台時，疑因誤觸開關，頭髮不慎遭瞬間高速運轉的機器捲入，導致頭皮整個被扯下，連上衣也被扯破，趴在機器上當場慘死，目擊並報案的同事顫抖地指出，看到她的頭皮掛在機器上，「真的相當恐怖，讓人不寒而慄。」
